Manhole Inspection Summary

Manhole # S35G__042MH

Inspection Is Incomplete Rating: **4) Poor**

Location Address: **light st**

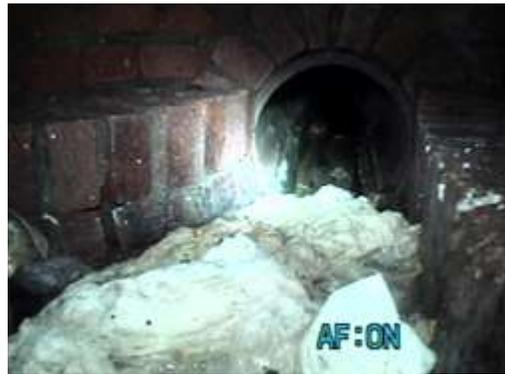
Defect 3

bench debris

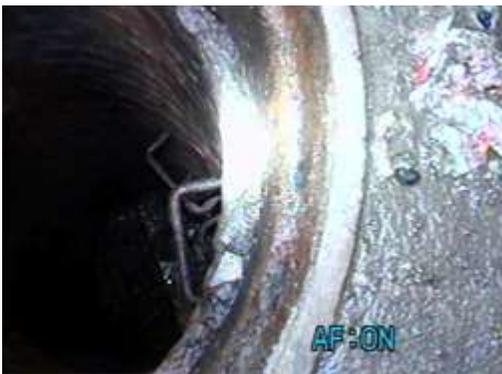
Defect 2

channel debris

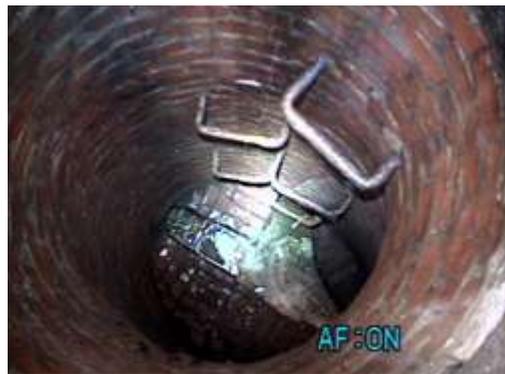
Defect 1

frame offset 2 inches

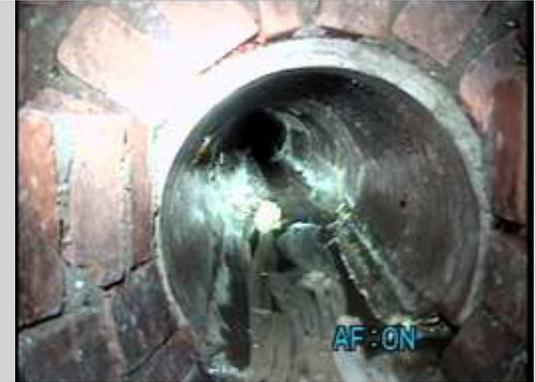
12 O'Clock Outflow

10 in. Circular Gravity Sewer
Pipe Out @ 12 O'Clock

Invert Depth: 10.66 (ft.) Flow Characteristics: **None**

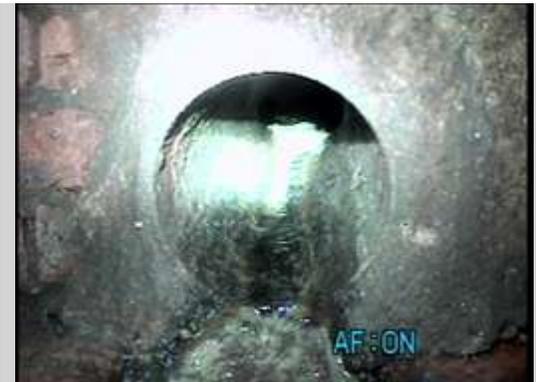
6 O'Clock Inflow

8 in. Circular Gravity Sewer
Pipe In @ 6 O'Clock

Invert Depth: 9.80 (ft.) Flow Characteristics: **Slow**

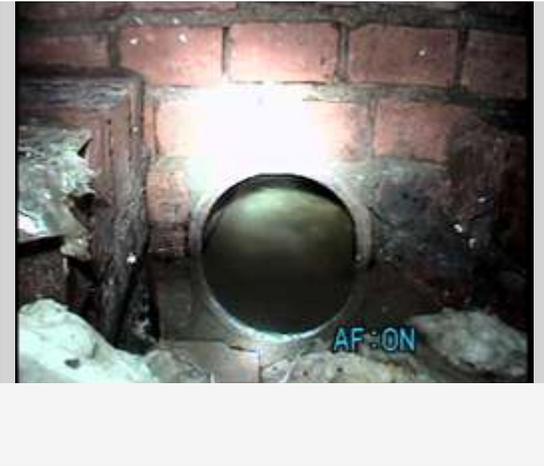
9 O'Clock Inflow

8 in. Circular Gravity Sewer
Pipe In @ 9 O'Clock

Connects To: House connection / Service line
